## *Effects of AC Stray Current on Concrete Structures*

The purpose of this article is the study of effects of high voltage AC stray current (220 and 380 VAC) on the durability of concrete. In rainy condition, high voltage AC current can leakage into water saturated concrete power pole by creeping AC current through their insulators. In Iran, large budgets are annually spent for replacing degraded concrete power poles with new ones. There is not any research on the above mentioned subject and the history of this research is related to the authors of this paper. Therefore, this study is a new work in the field of concrete.

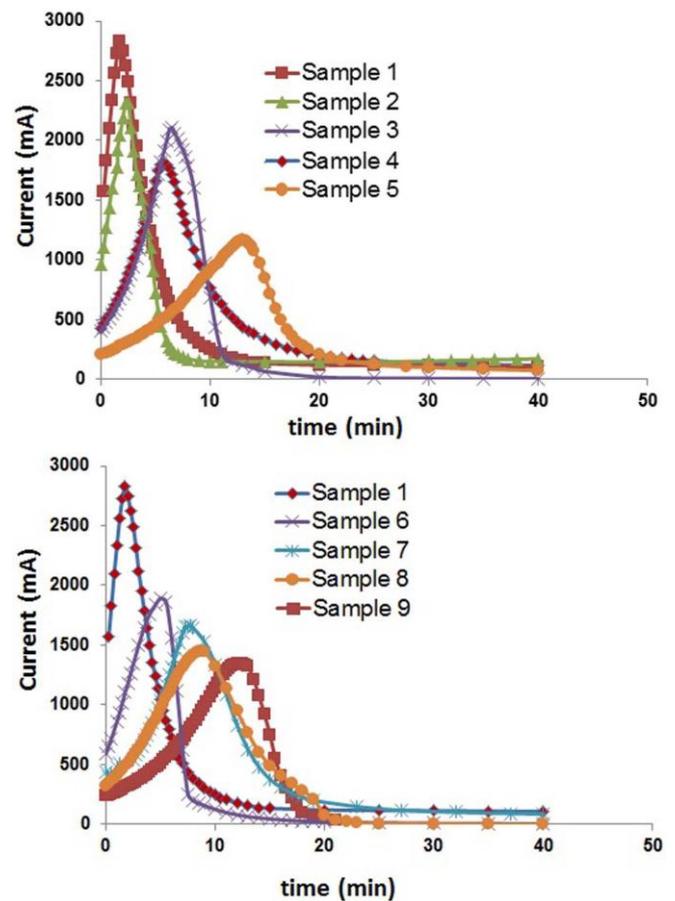
Figure 1: Current-time curve during application of 380 VAC on concrete samples. Curve of sample 1 in part (a) and (b) repeat for comparison.

According to Figure 2, the AC current in the concrete samples rapidly increased and reached a maximum value and then rapidly reduced to a low level. This phenomenon can be justified by using the electrical model for concrete. In this model, the AC current can pass through two different paths in the concrete including resistor and capacitor paths. The capacitor path is a pore path of concrete and the resistor path is an aggregate and cement paste of concrete [3], [4]. According to the model and Electrochemical Impedance

In other words, impedance of the capacitor paths compared to the resistor path is very low and most of the current passes through the capacitor path (pore paths). For this reason, in the first step of current-time curve of Figure 2, serious non-uniform AC current distribution forms in the concrete samples and is cause for creating heat and thermal stress. According to the test results, the thermal stress is high enough to create micro-cracks in concrete and generation heat is cause for evaporation water of concrete.

Therefore, in the first step of curves of figure 1, porosity of concrete increases and current rapidly increases. When water of pores evaporates, the pores paths cannot act as capacitor path and current reduces rapidly. Therefore, the high voltage AC stray current can increase permeability of concrete in a short time and can reduce its durability.

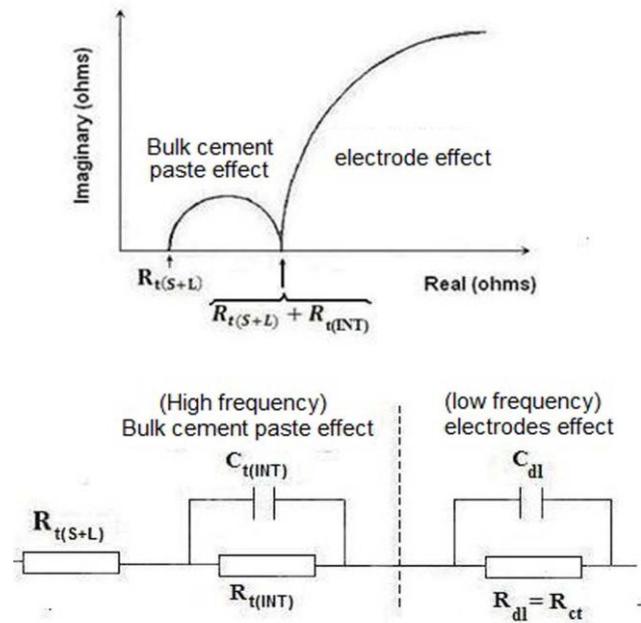
Figure 2: a) Schematic of EIS spectra of concrete, b) Equivalent electrical circuit for concrete [4].

Spectroscopy (EIS) spectra of concrete (**Error! Reference source not found.**), impedance of concrete in the intersection of low and high frequency is minimum. Meanwhile, according to EIS test results, the frequency of this impedance is about 50-60 Hz. Therefore, urban AC power has minimum impedance in water-saturated concrete.
